TEST REPORT

SAMPLE DESCRIPTION : HUMIDIFIER

STYLE / ITEM NO. : [REDACTED] IP-5025

Test Result:
French Law No. 2012-1442 Bisphenol A content

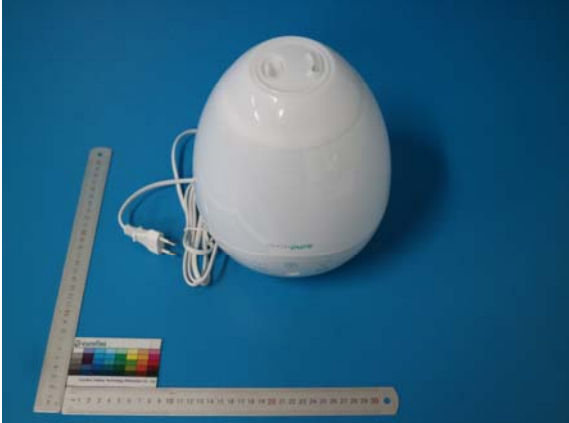
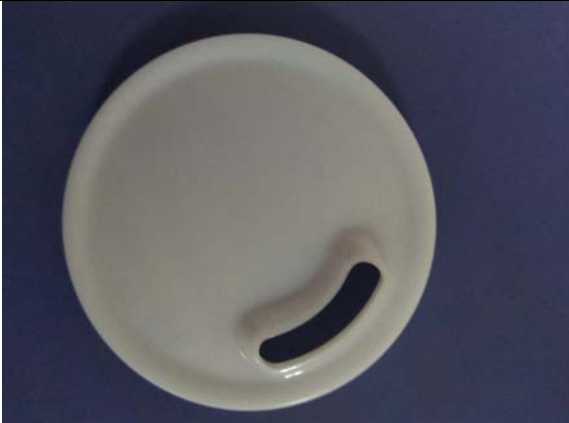
Photo Attachment	
HUMIDIFIER

The photo below is attached only for the customer's reference. However, it is irrelevant in the testing process.
